Monthly Field Oversight Summary Report 2
ACS NPL Site
Griffith, Indiana
February 1, through March 2, 2001

BVSPC Project 46518
BVSPC File C.3
April 5, 2001

Subject: Monthly Oversight Summary Report
No. 2

Monthly Oversight Summary Report No. 2
ACS Superfund Site WA30, 46518.238

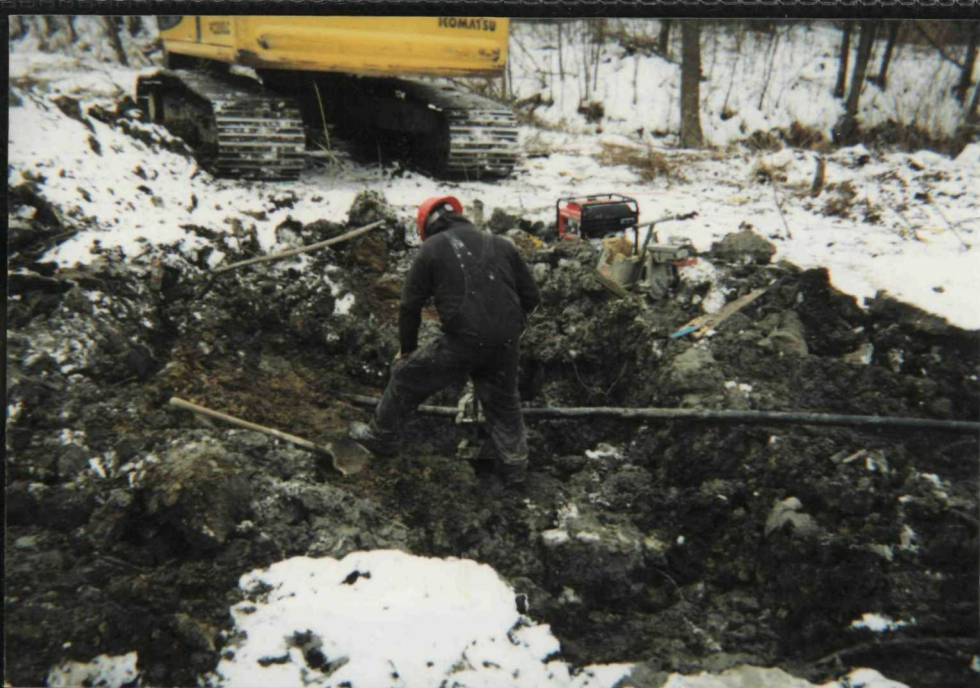
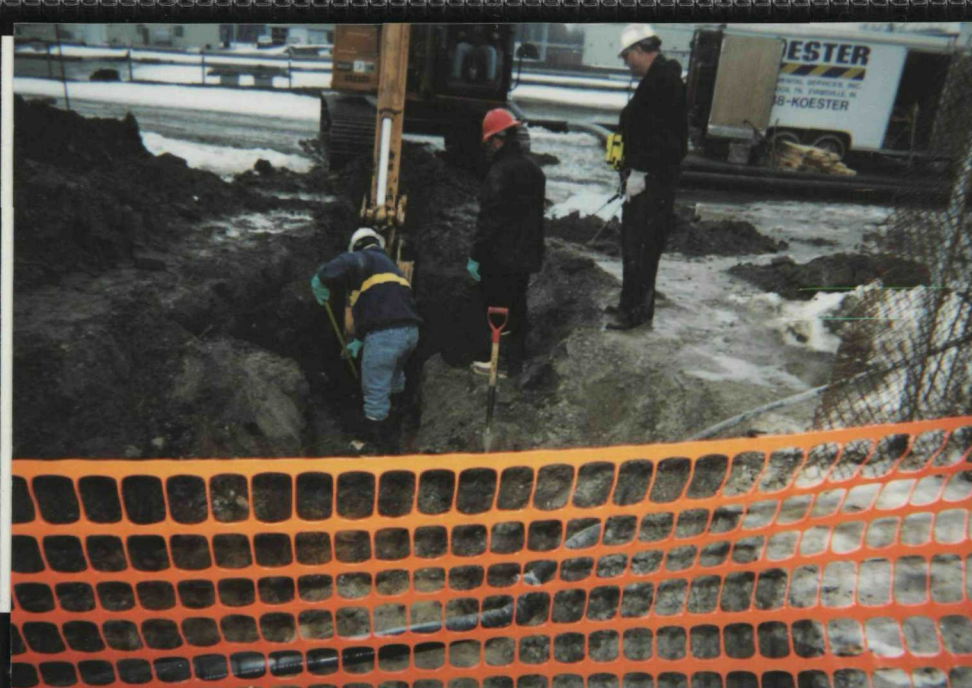
Description: Photo facing south at the offsite
area of CDS excavating to
reconnect existing piping damaged
during trenching activities.

- 10:16 Picture 16 Role 4 Facing South in the OFF SITE AREA, of CDW opening up excavation pit to Reconnect the extraction Pipe.
- 10:46 Picture 17 Role 1 Facing South in the OFF SITE AREA, of CDW welding HDPE in trench excavation for existing EXTRACTION LINES. Air Monitoring is Being Performed as Real Time. By Susan.
- 11:00 KES is still welding HDPE for Pipe up GRADE.
- 11:46 CDW Finished the HDPE Replacement. Part of CDW's staff is still
- 12:14 KES & CDW ARE Taking Lunch
- 12:53 Return to Site, CDW is Back Filling the two Reconnection site of HDPE at the two ENDS OF THE Separation wall.
- 13:04 KES is still welding HDPE.
- 13:47 KES Back hoe was Delivered & UNLOADED to ON SITE AREA.

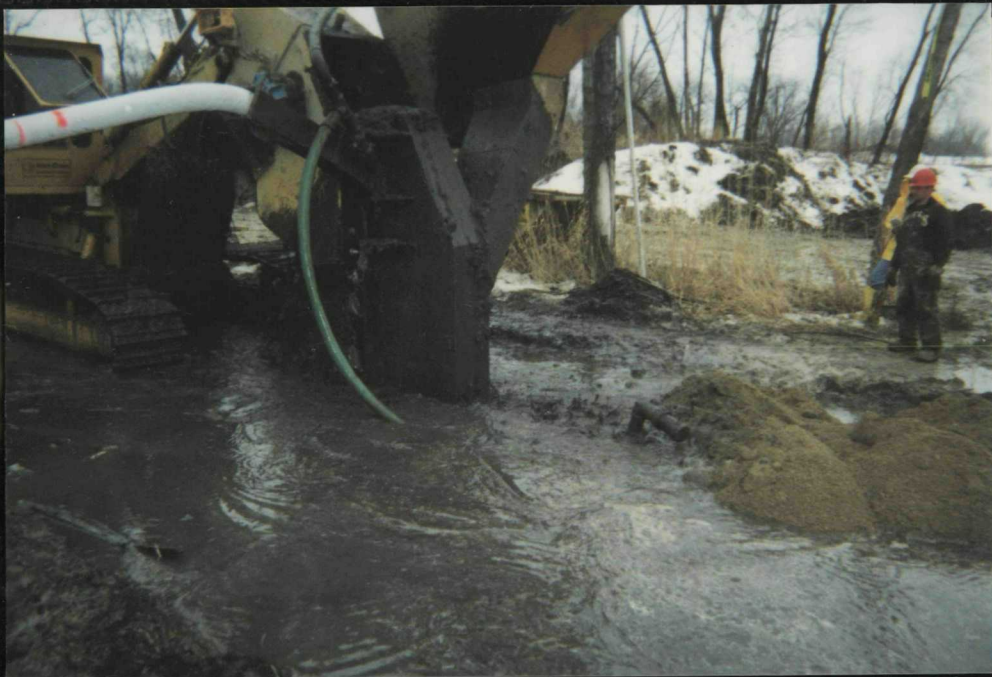
Site: American Chemical Services, Inc.
 Proj. #: 46518
 Roll: 1 Photo #: 19
 Date: 02-08-01 Time: 08:03
 Photographer: Chad Gailey
 Description: Photo facing east at water
 treatment plant of the excavation
 through the barrier wall by KES.

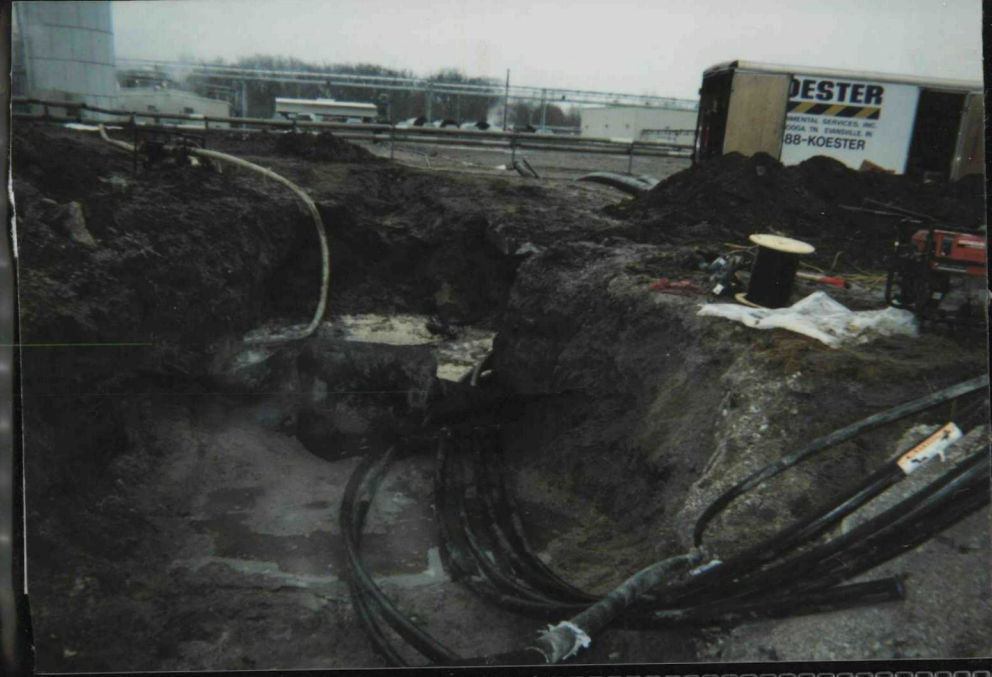
- Koester Environmental's penetration of the perimeter barrier wall has caused water leakage from the onsite area to the area next to the water treatment plant. BVSPC suggested a sump pump be installed to lower water level to prevent further leakage until the installation of the piping upgrade in this area is installed. Koester Environmental is performing periodic dewatering per Montgomery Watson's direction.

Site: American Chemical Services, Inc.
 Proj. #: 46518
 Roll: 1 Photo #: 20
 Date: 02-08-01 Time: 09:00
 Photographer: Chad Gailey
 Description: Photo facing east at water
 treatment plant of water seeping
 over the barrier wall.

9:00 Picture 20# Pole 1 Facing East
@ Piping Trench. Near WTB, of
water seeping over the Barrier
wall.

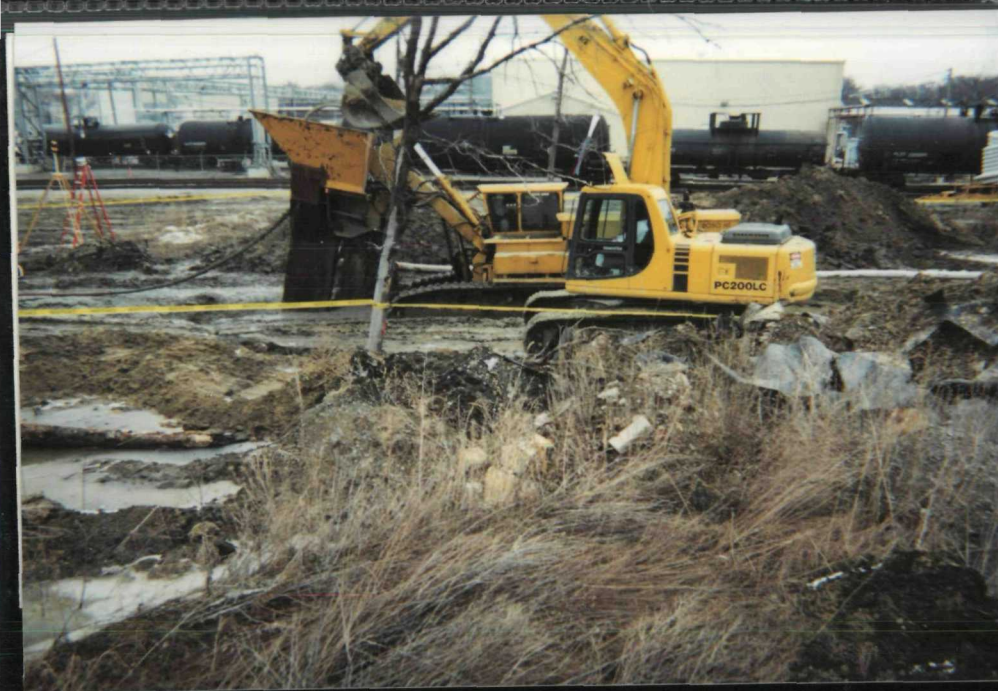
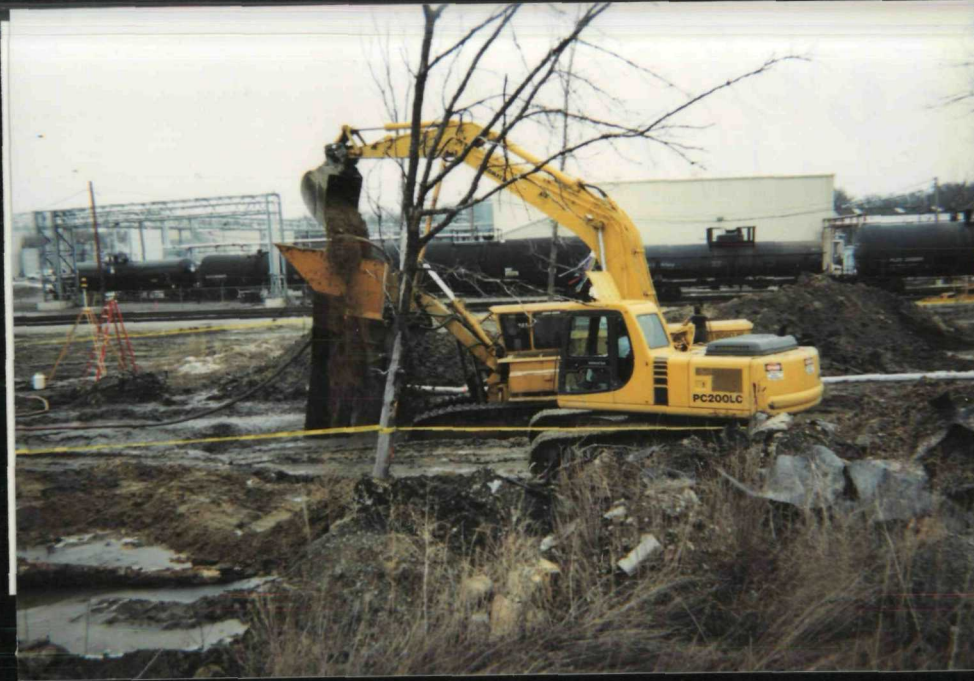
Site: American Chemical Services, Inc.
 Proj. #: 46518
 Roll: 2 Photo #: 5
 Date: 02-13-01 Time: 10:43
 Photographer: Chad Gailey
 Description: Photo facing south in the onsite
 area of KES repairing an ACS
 culvert hit during excavation.

- 10:43 Picture #5 Role 2, Facing South in on side AREA, of the KES Repairing an ACS Solvent.
- 10:47 Air Monitoring is taking place @ the Pipe Welding Zone.
- 11:11 CDS is PENDING OF Level "C".
Elevation is Being Established / LMSAR Level.
- 11:23 Trenching BEGIN - MW Left the AREA, CDS is TAKING Health SAFETY READING.
- 11:30 Picture 6 Role 2 Facing North @ OFF site away of CDS Installing EW20.
Susim. is Checking the CAB of trench w/ PID AND is pulling Dragger tube.
- 11:36 Picture 8 Role 2 Facing SW @ OFF site Area of CDS, Installing EW20.
- 11:37, Picture 9 Role 2 Facing S looking Down, @ HDPE AND the ASTM ON the Pipe.

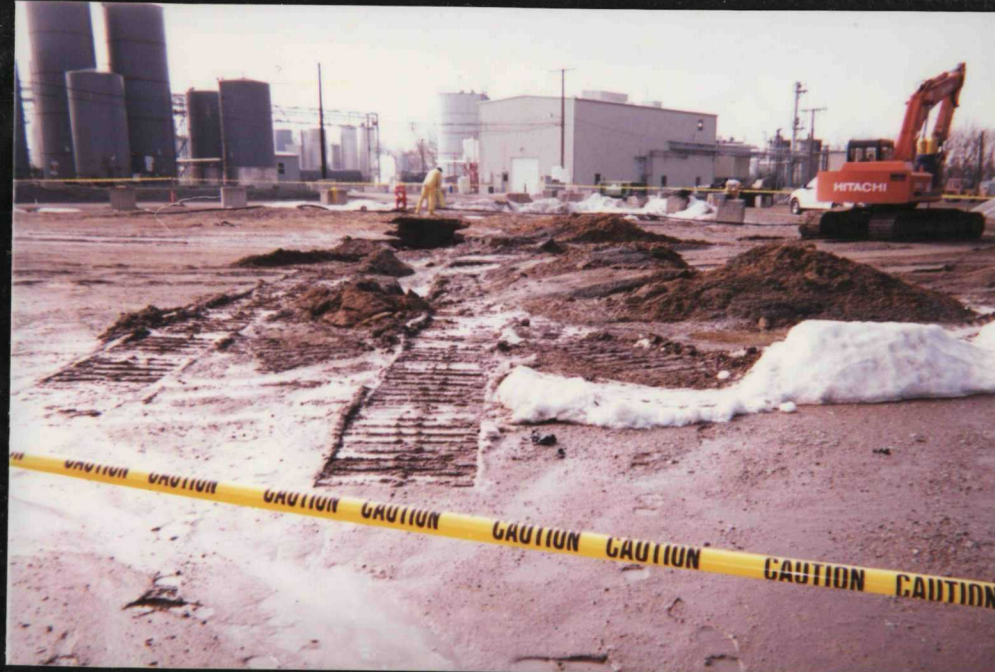
Description: Photo facing south at area A of the drum demarcation area trench.

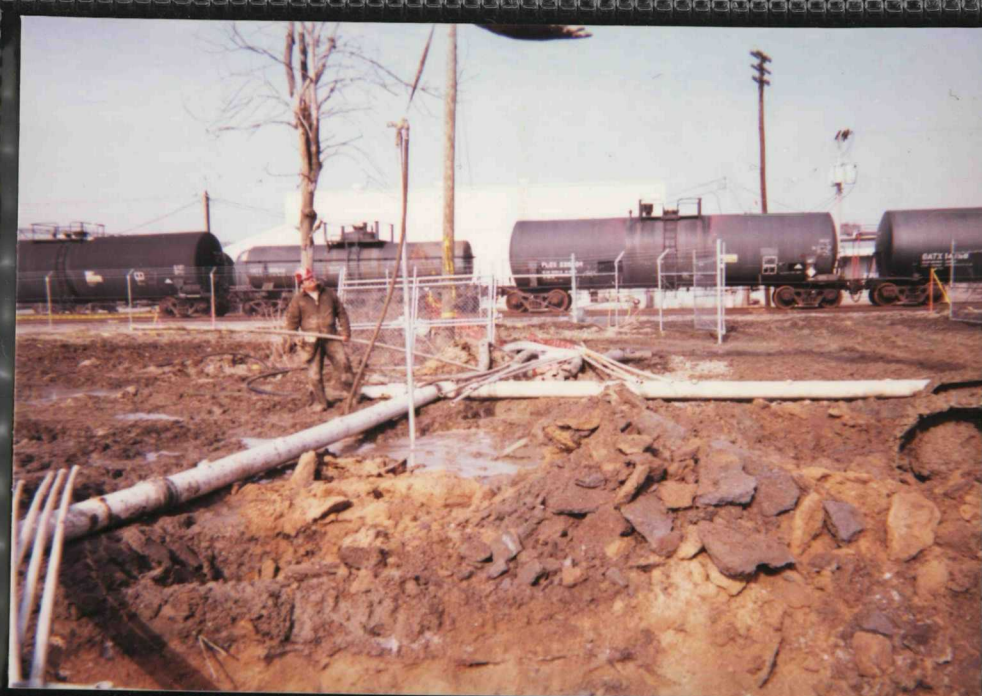
Description: Photo facing south of CDS jetting in well points for extraction recovery of the end of EW20.

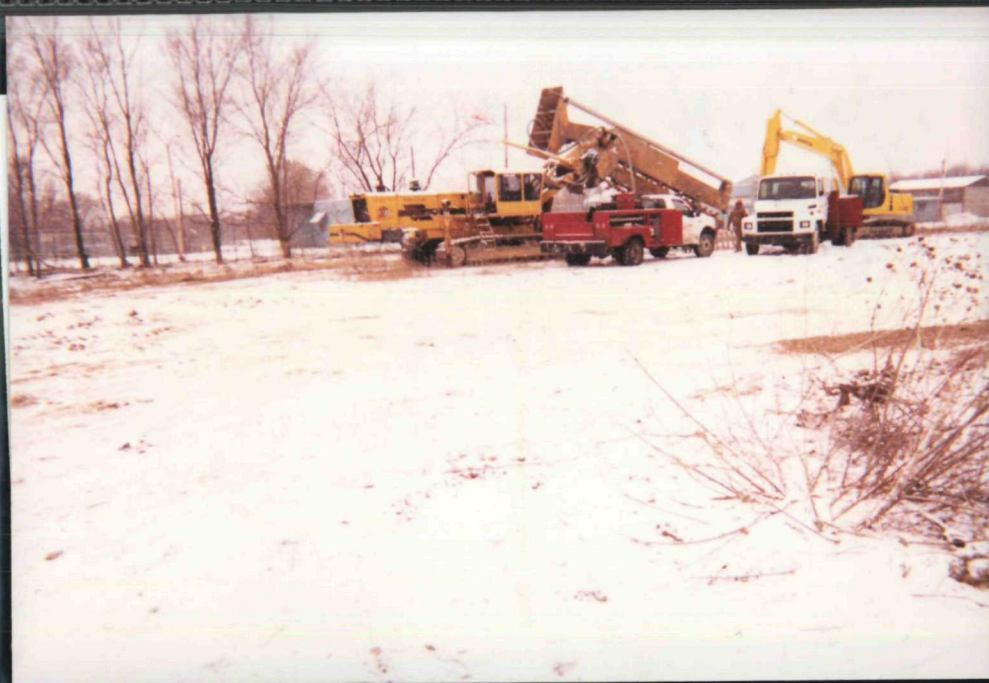
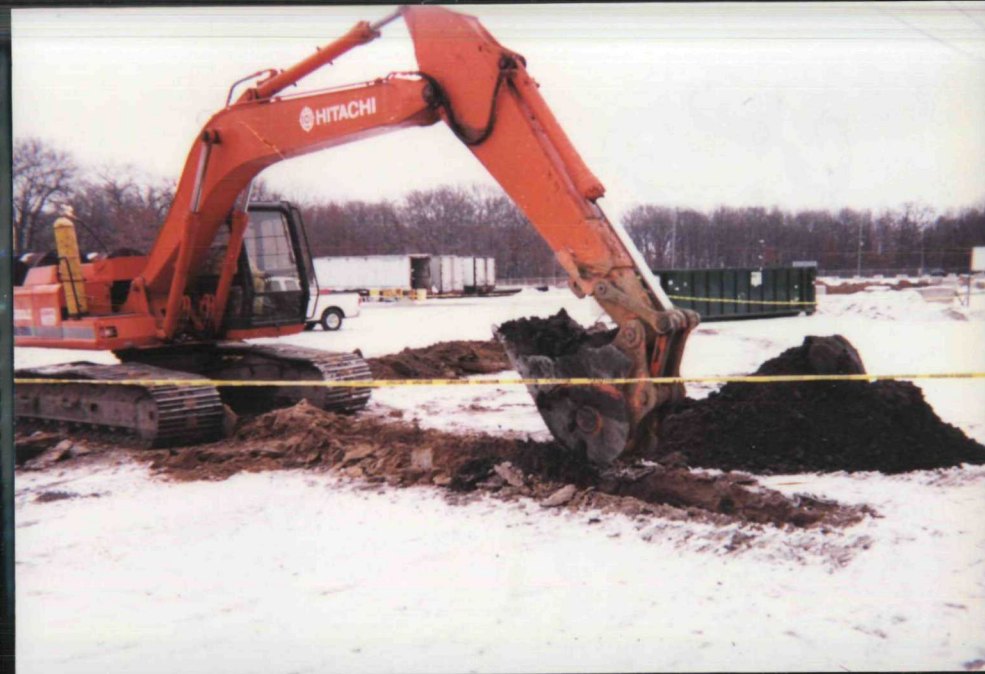
Description: Photo facing north at area A of the drum demarcation.

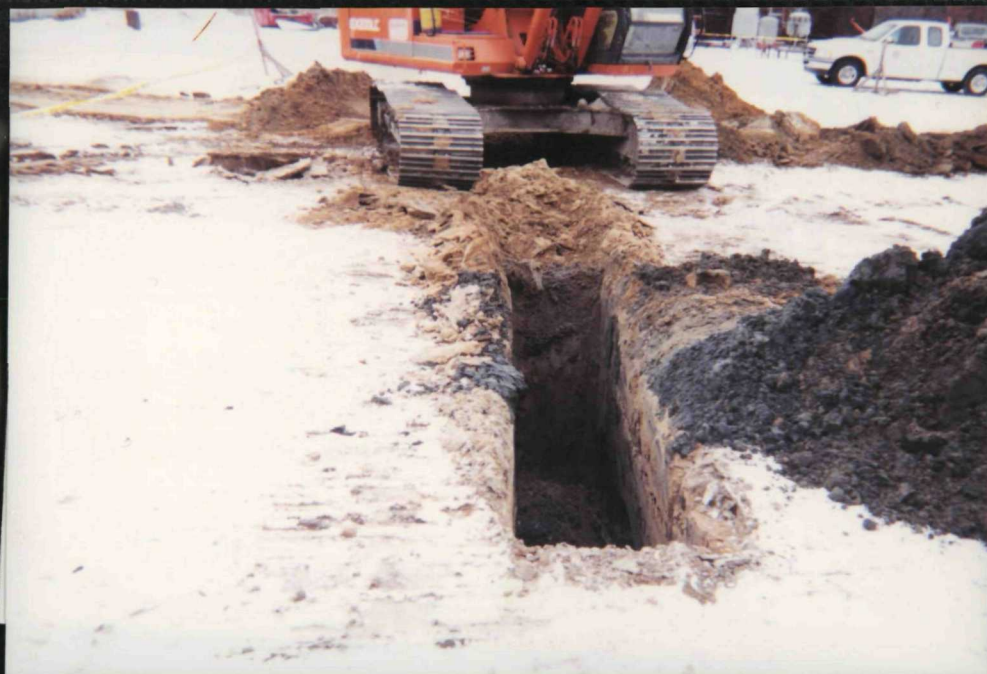
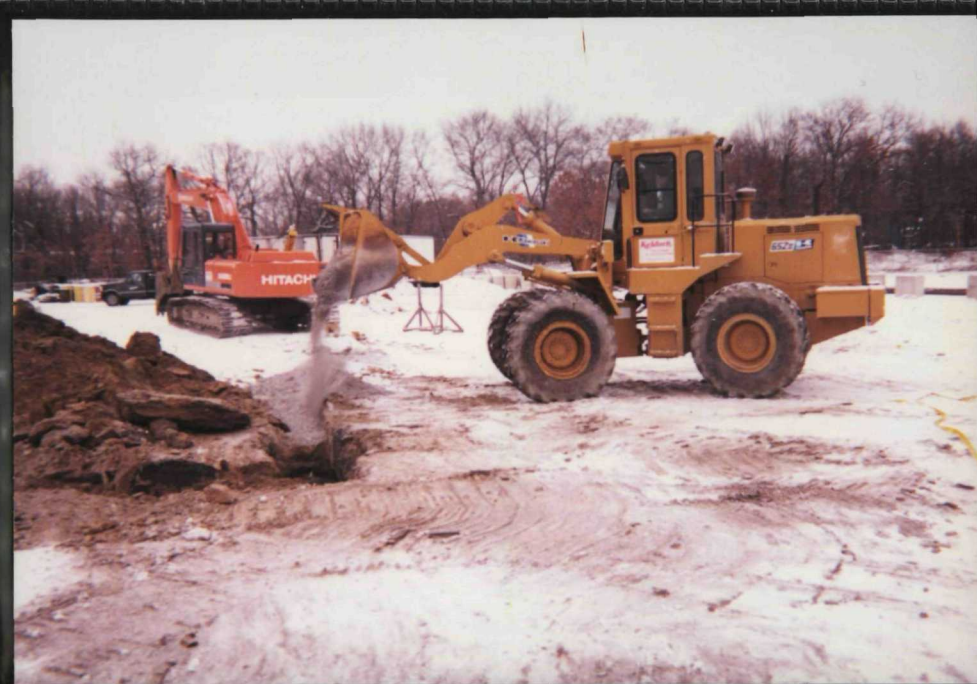
Description: Photo facing northwest at area A of
MEI backfilling demarcation
trench.

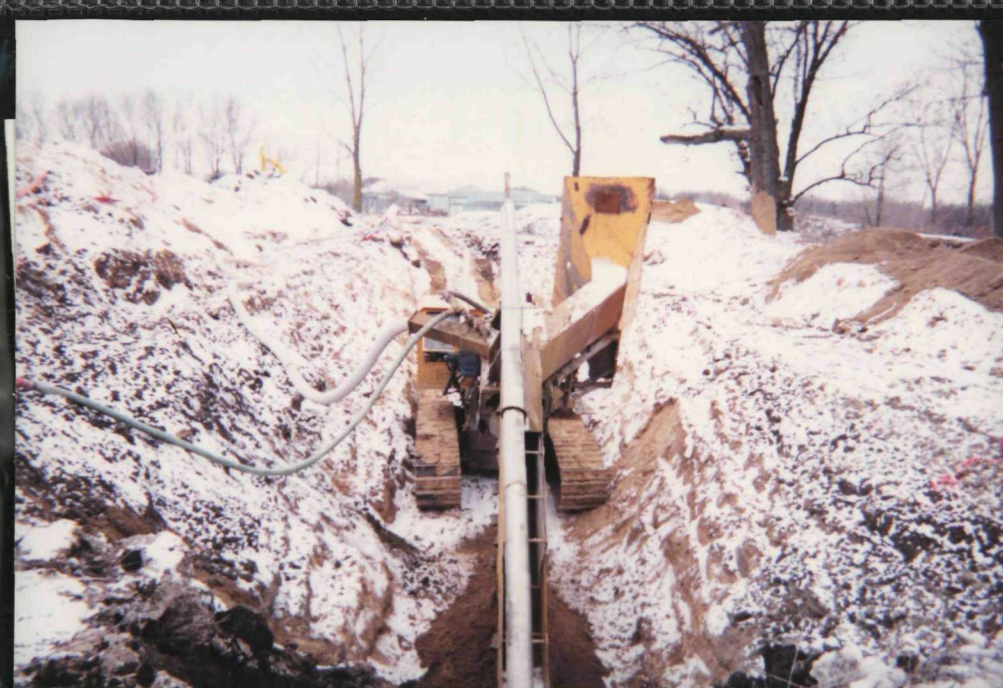
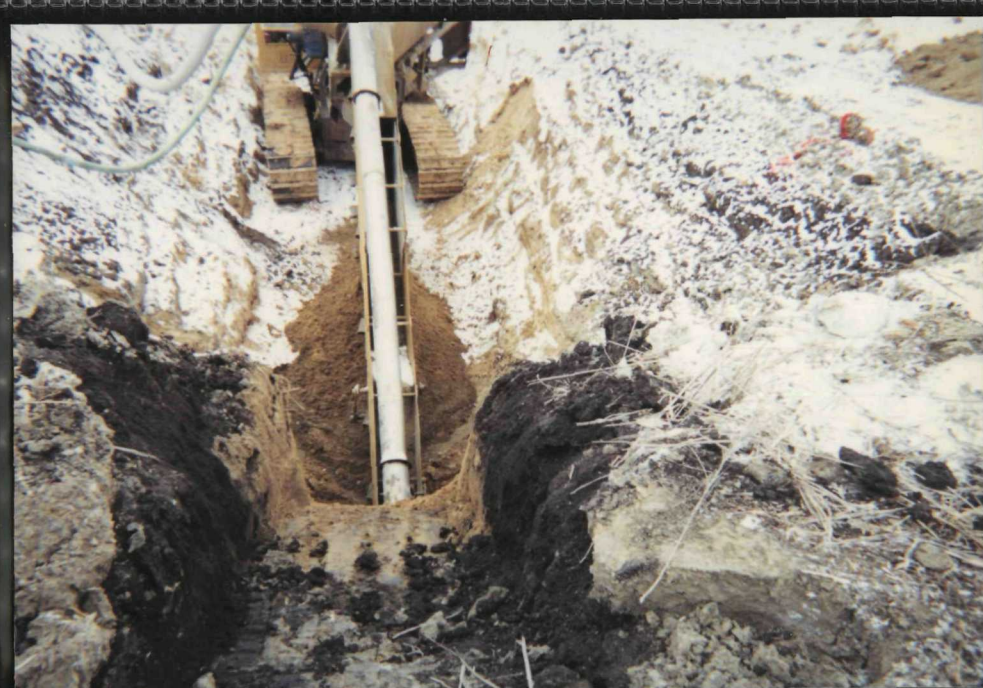
Description: Photo facing south at EW19 of
CDS setting up for installation of
EW19.

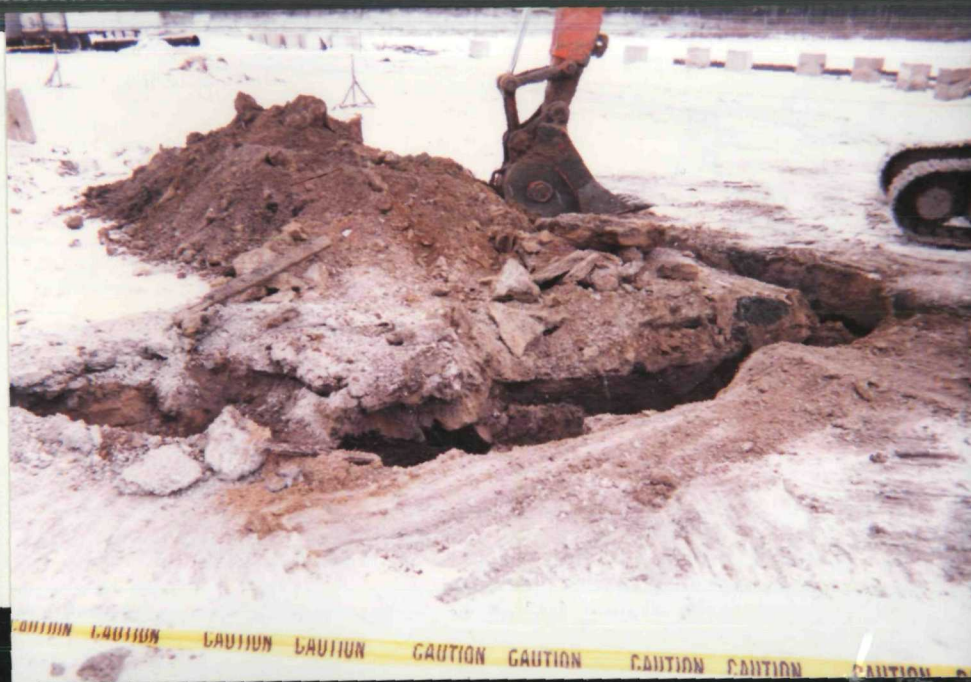
Description: Photo facing northeast at area C of the drum demarcation, no drums were found.

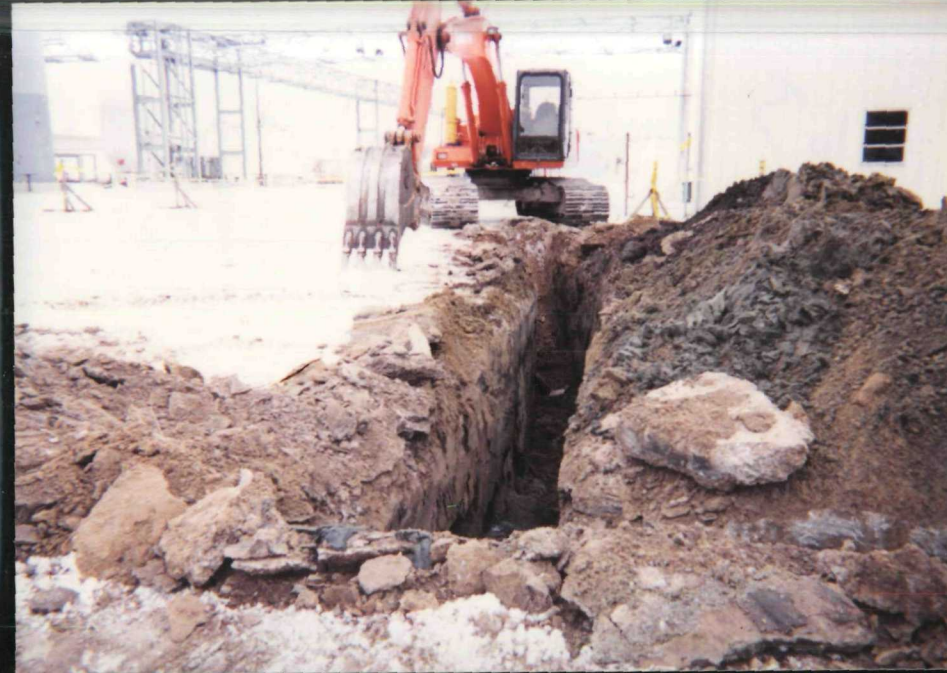
Description: Photo facing south at the north end of area C drum demarcation.

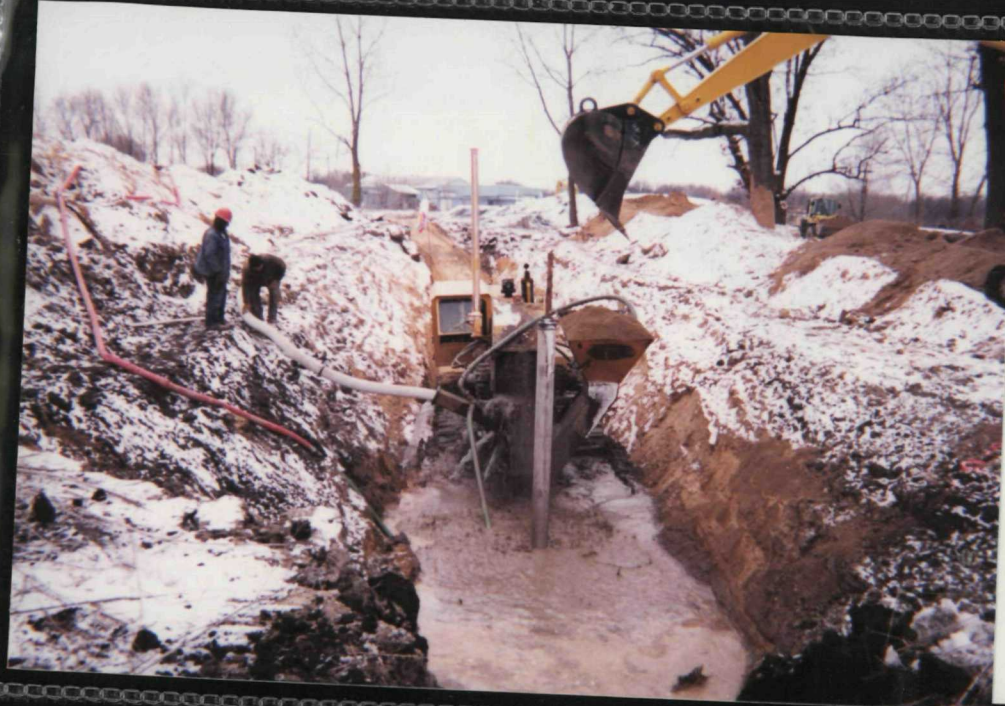
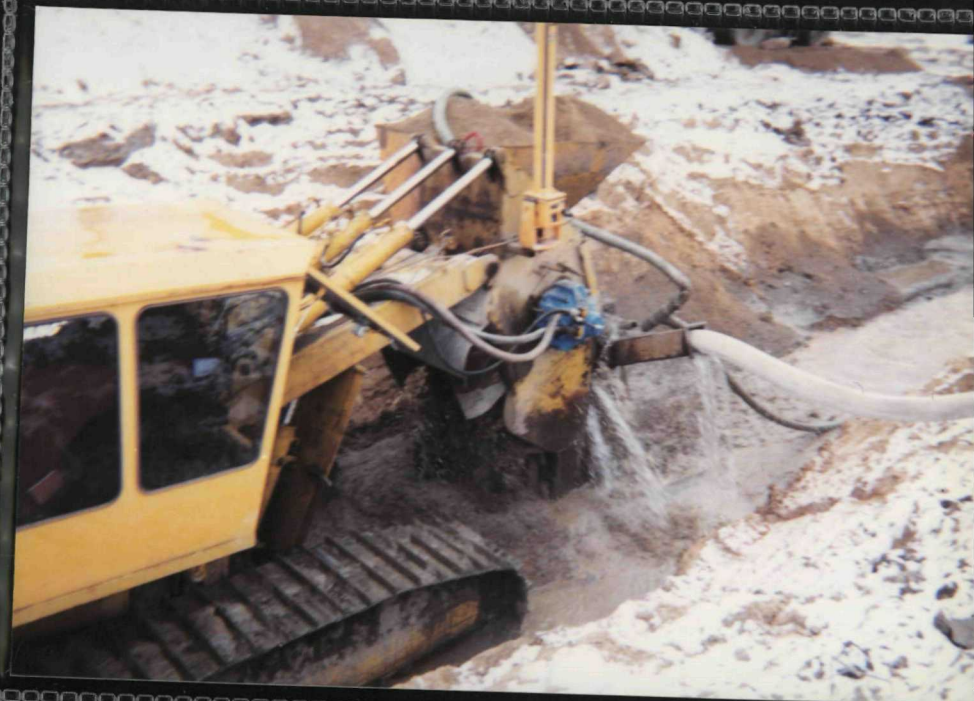
Description: Photo facing west on the east side
of EW19 of CDS installing
extraction trench EW19.

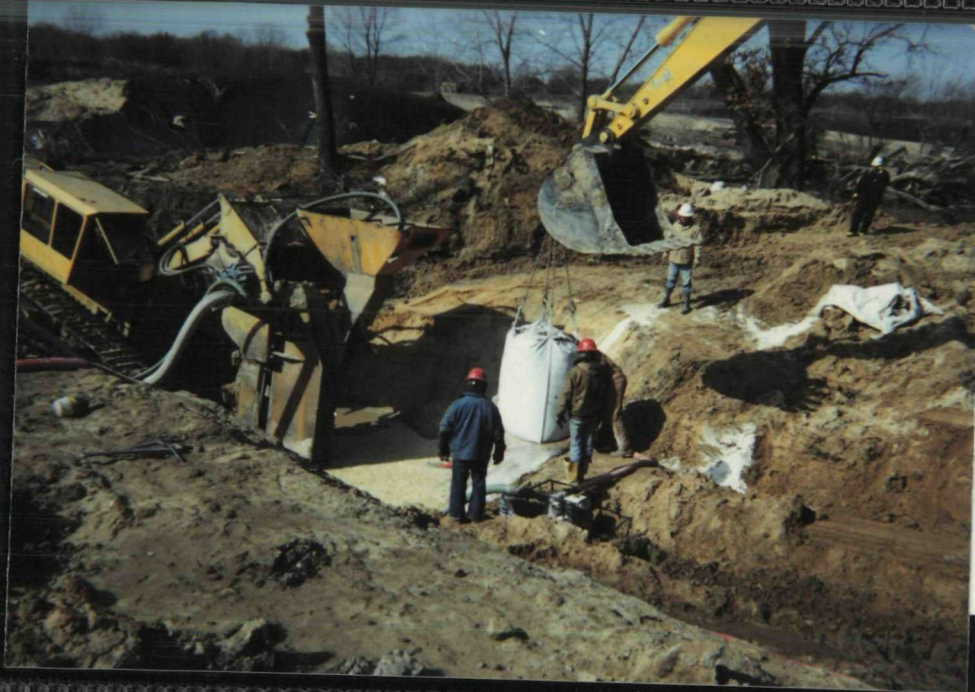
Description: Photo facing southwest at EW19 of CDS
adding bentonite to the hole to hold the
walls.

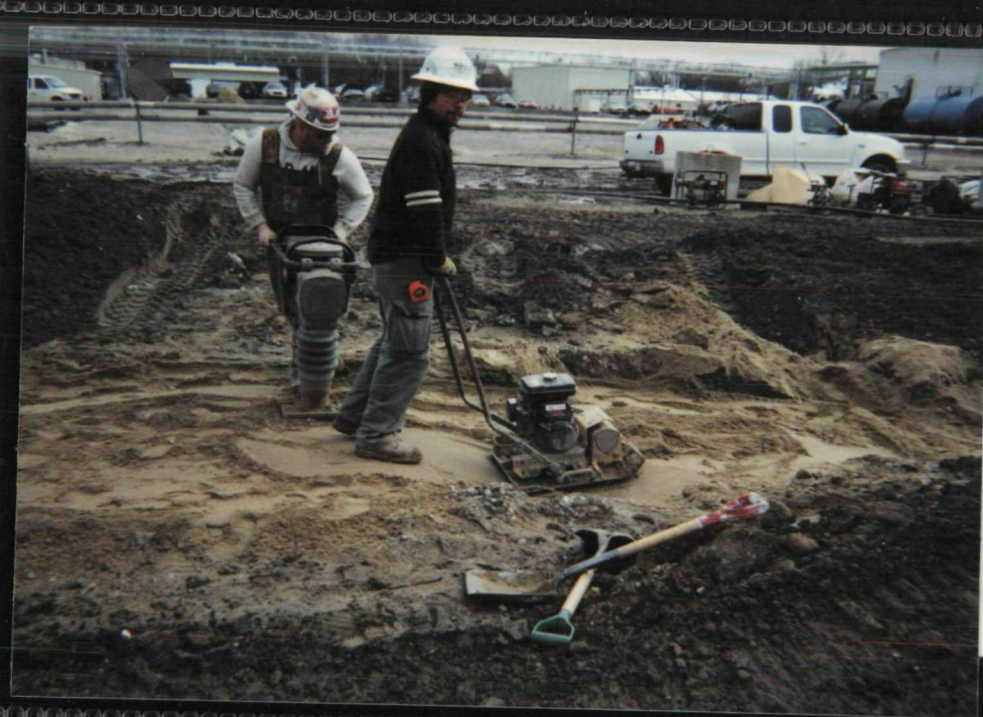
Description: Photo facing east at onsite conveyance
trench of KES compacting backfill.

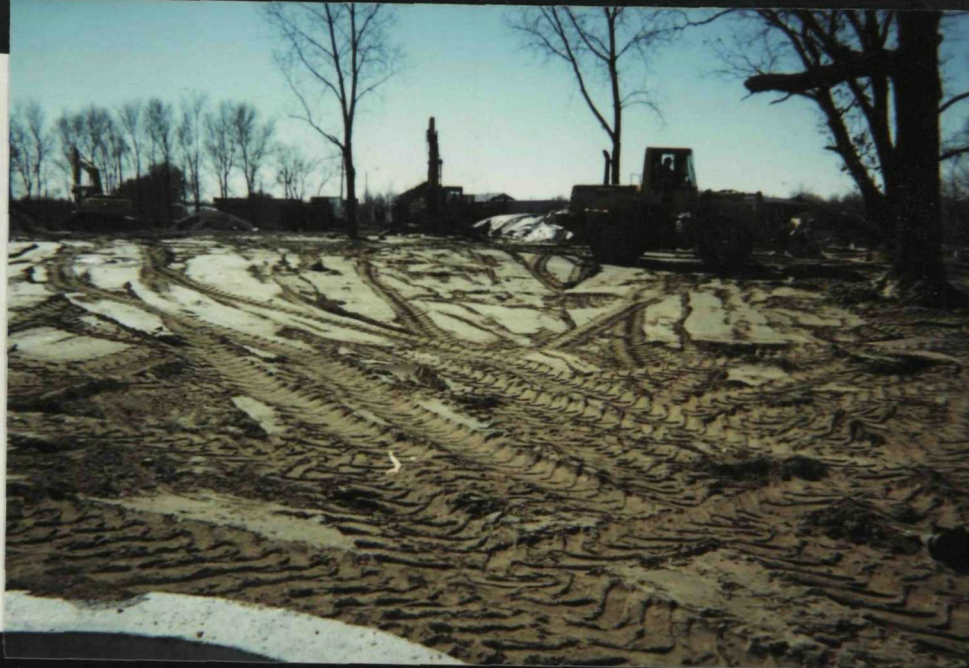
Description: Photo facing south at EW19 of CDS
backfilling and grading EW19 area.
